# Failure Analysis of Tire Tread Separations

J.W. Daws

In-service catastrophic radial tire failure is often a separation of the tread and outer steel belt from the tire casing and inner steel belt. These separations generally occur in the field at high temperature and high speed. This paper presents a catalog of surface characteristics that define the various types of rubber cracking that take place during a tire belt-leaving-belt separation. A mechanism that explains the generation of the rapid tearing surface is used to detail the variation found in forensic examinations.

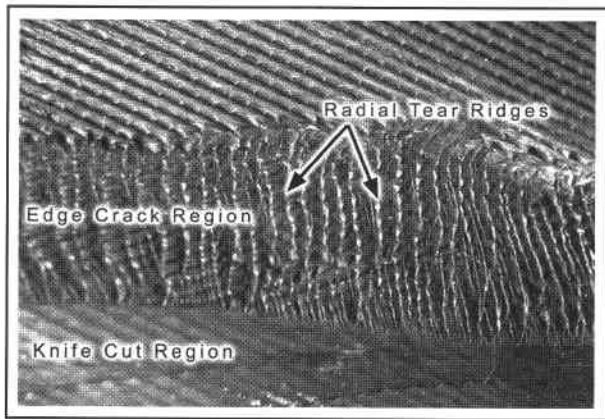
Figure 2 shows a photograph\* of edge cracks that were generated in the laboratory. The smooth surface in the lower third of the figure is a region that had been cut with a knife in order to facilitate rapid separation in the laboratory. The cracks grew from this knife-cut region toward the centerline of the tire. The edge cracks have a characteristic ridge appearance and are oriented vertically in Fig. 2. The definition of these cracks is very sharp because they were generated in seconds in the laboratory setting, as opposed to a field tire failure where the crack growth generally takes place over years. Figure 3

Fig. 2 Edge cracks created in a laboratory tire tread separation

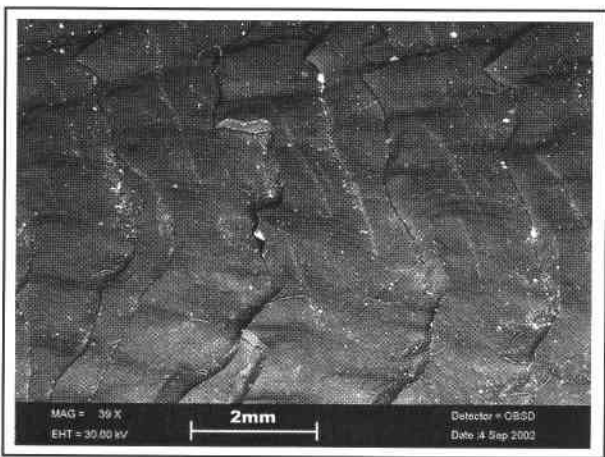
Fig. 3 Micrograph of edge cracks showing beach marks and radial tear ridges

shows a micrograph of a small region of the edge cracks. Beach marks running perpendicular to the direction of crack growth can be clearly seen. These beach marks denote the crack tip or front at a particular time in the crack development sequence. Note that the beach marks terminate at what appear to be ridges or radially oriented steps. These ridges separate regions where the crack growth from each initiation point occurs on a slightly different path within the bulk of the skim rubber. The radial tear ridges are also the predominant visual aspect of the edge tears.

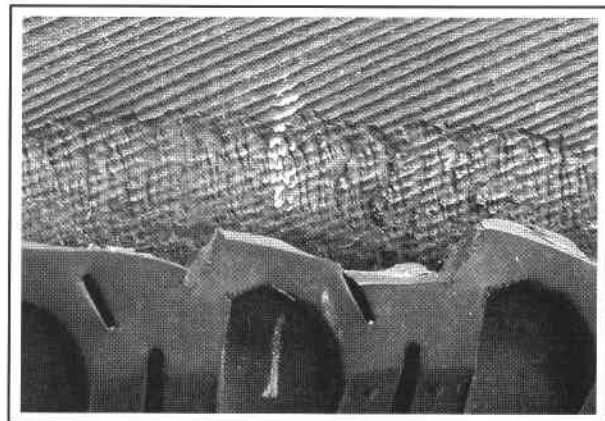
Fig. 4 Sample of edge cracks occurring in a field tire tread separation (serial side)

tion. In Fig. 4, the edge cracks grew from the Serial Side belt edge upward toward the tire centerline in the same manner as those in Fig. 2. In Fig. 5, the edge cracks grew from the Opposite Serial Side belt edge downward toward the tire centerline. The edge cracks grow from the edge of the outer steel belt into the skim rubber between the two steel belts, and they normally occur simultaneously on both sides of the tire. Because the initial fatigue crack growth rate in field tires is very low (many orders of magnitude lower than that found by Daws<sup>[2]</sup> in laboratory experiments), polishing of the edge crack surfaces due to relative movement of the crack surfaces normally occurs. The relative movement of the crack surfaces is caused by the strains generated when the tread is in road contact during each rotation. This polishing reduces the sharpness of the radially oriented tear ridges that characterize these cracks.

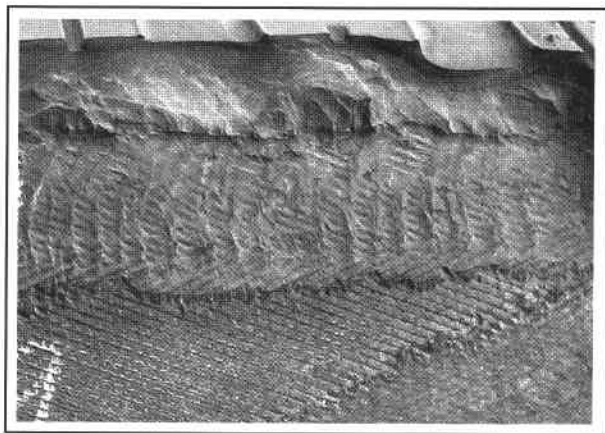
Fig. 5 Sample of edge cracks occurring in a field tire tread separation (opposite serial side)

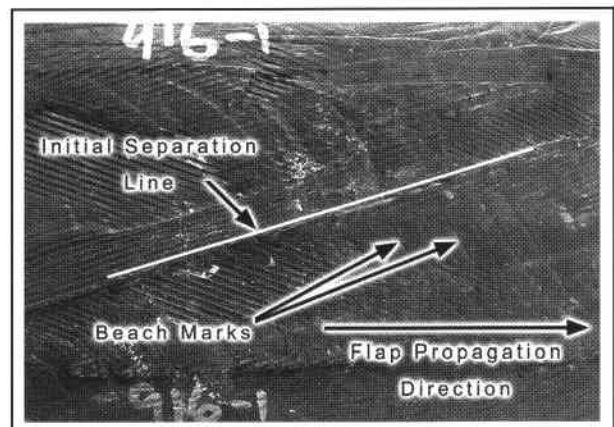
Figure 6 shows the initial separation line for flap formation from a tire having a laboratory-created separation. The initial separation line is highlighted for clarity. In this case, both the leading edge and trailing edge flaps were torn loose; that is, there was no edge crack thumbnail pocket under either flap. The result is that there are beach marks emanating from the separation line that define the tear progression of the flaps. The propagation direction of the flap is shown for the flap below the separation line. Figure 7 shows an example of a flap initiation region in a field tire where there was tearing of the flap at the time of the separation. Beach marks can be seen faintly in the surface of the rubber. Figure 8 shows an example of another tire that experienced a separation in field service. Below and to the right of the separation line (highlighted for clarity) is a thumbnail pocket that was developed by the edge cracks growing and linking together under fatigue loading. In this particular case, the edge crack pocket extended approximately 85% of the way across the tire tread area before the flaps formed and the tread and outer steel belt separated. As would be expected, there was a significant amount of polishing at the tire shoulder due to the large interfacial movement that occurs in a pocket of this size. Additionally, the crack surfaces near the tire centerline are distorted. In fact, the flap tips in this case did not generate the characteristic beach marks because once the

Fig. 6 Initial flap tearing region occurring in a laboratory tire tread separation

tread and outer steel belt broke at the tire shoulder, the flap was already separated for nearly the full width of the tire. As seen in the laboratory tire tread separations, rapid tearing of the flap normally begins at the point where the flap width is approximately equal to the tread width. For the tire in Fig. 8, at the time of separation, no further tearing was required to allow the flap to separate completely from the casing and begin to tear away.

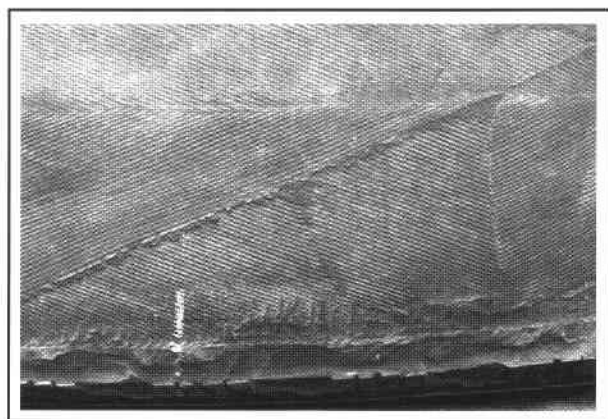
Fig. 7 Flap initiation region occurring in a field tire tread separation

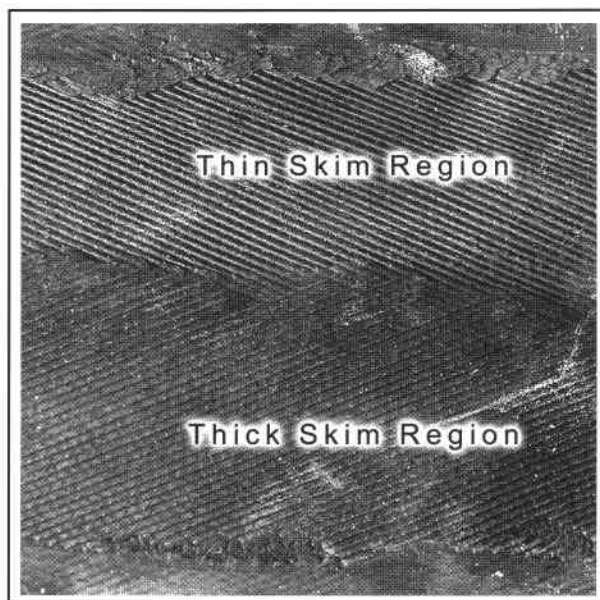
separates these two zones. The resulting thick-thin aspect of the skim rubber remaining on the outer surface of the inner steel belt is very distinctive. Figure 9 shows a portion of the rapid tearing region from a laboratory separation. This particular sample was from a trailing edge flap on a right-side tire. Figure 10 shows the rapid tear region on a tire that experienced a field tread separation. The tire was mounted on the left side of the vehicle, and the sample shown in the photograph was produced by the leading edge flap. In both of these photos, the

Fig. 9 Rapid tearing region occurring in a laboratory tire tread separation (trailing edge flap, right-side tire)

The direction of propagation of the tear and the tire's rotational direction determine whether the skim remaining on the outer surface of the inner belt will be thick or thin on the Serial and Opposite Serial sides of the tire. As seen in Fig. 9 and 10, the region of thin skim shows wire lines from the inner steel belt in the upper portion of the photographs (the Opposite Serial Side of the tire), while the region of thick skim in the lower portion of the photographs (the Serial Side of the tire) shows wire lines from the outer steel belt.

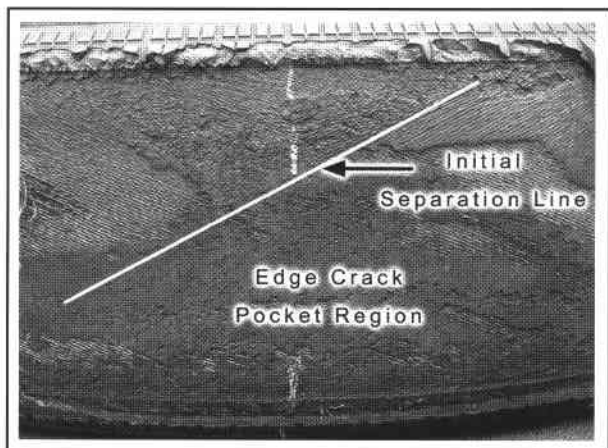
Fig. 8 Flap initiation region occurring by growth of edge crack pocket under flap in field tire tread separation

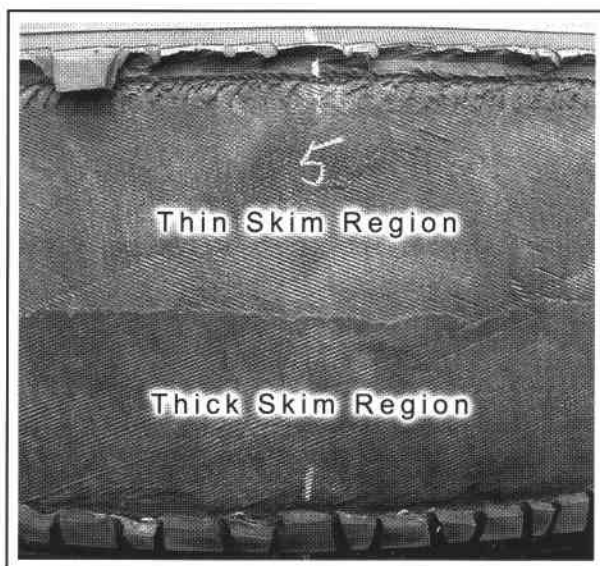
Fig. 10 Rapid tearing region occurring in a field tire tread separation (leading edge flap, left-side tire)

impression of the outer steel belt wires created a pattern of lines moving from the tire centerline to the lower left. The impression of the inner steel belt wires created a pattern of lines going from the tire centerline to the upper left. This herringbone pattern is characteristic of the rapid tearing region of a tire tread separation.
