# Failure Analysis of Tire Tread Separations

J.W. Daws

In-service catastrophic radial tire failure is often a separation of the tread and outer steel belt from the tire casing and inner steel belt. These separations generally occur in the field at high temperature and high speed. This paper presents a catalog of surface characteristics that define the various types of rubber cracking that take place during a tire belt-leaving-belt separation. A mechanism that explains the generation of the rapid tearing surface is used to detail the variation found in forensic examinations.

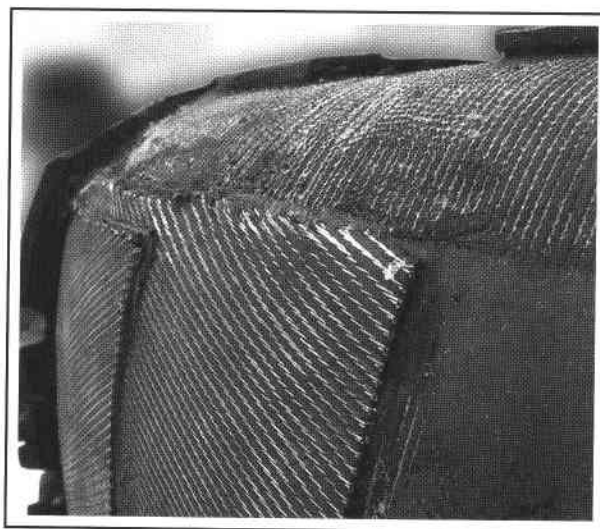
The modern steel-belted radial tire incorporates two steel belts, with twisted steel cord embedded as reinforcement in the rubber of the tire. Figure 1 shows a tire that has been sectioned to show the steel belts and their position on the casing body ply cords. As seen in Fig. 1, the steel wires of the inner and outer steel belts are laid in different directions in order to provide a reinforcement of the tread area. The resulting rubber-steel composite carries the loads associated with the road contact of the vehicle on which it is mounted. In the inflated and undeformed state, any portion of the tire's tread and steel belt system will normally have a compound curvature. When the tread and steel belt system comes in contact with the road, the geometry must conform to the road surface. This imposed geometry creates a shear strain between the inner and outer steel belts. The strain is due to the asymmetry inherent in each

Fig. 1 Radial tire cutaway showing the steel belt reinforcement system

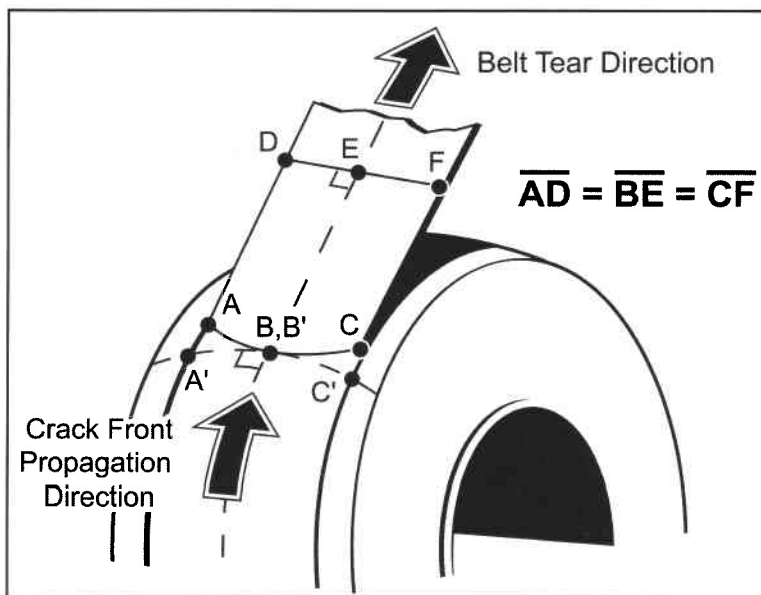
The locations of the thick and thin skim arise due to the compound curvature of the tire's surface. When the tread and outer steel belt pull from the inflated casing, the edge of the crack forms an arc in the direction of propagation of the tear. This arc has the appearance of a "C," with the open end toward the direction of crack propagation. Figure 11 shows a sketch of the development of this crack front shape. Curved line A'B'C' is drawn parallel to the tire body ply cords and is therefore perpendicular to the tire centerline. Straight line DEF is a line perpendicular to the centerline of the belt that is tearing

Fig. 11 Sketch showing the shape of the crack front in the rapid tearing region
